Geological Report on the Pollatomish Landslide Area, Co. Mayo

October 2003

**Geological Survey of Ireland,
Beggars Bush,
Haddington Road,
Dublin 4,
Ireland**

Internal Unpublished Report

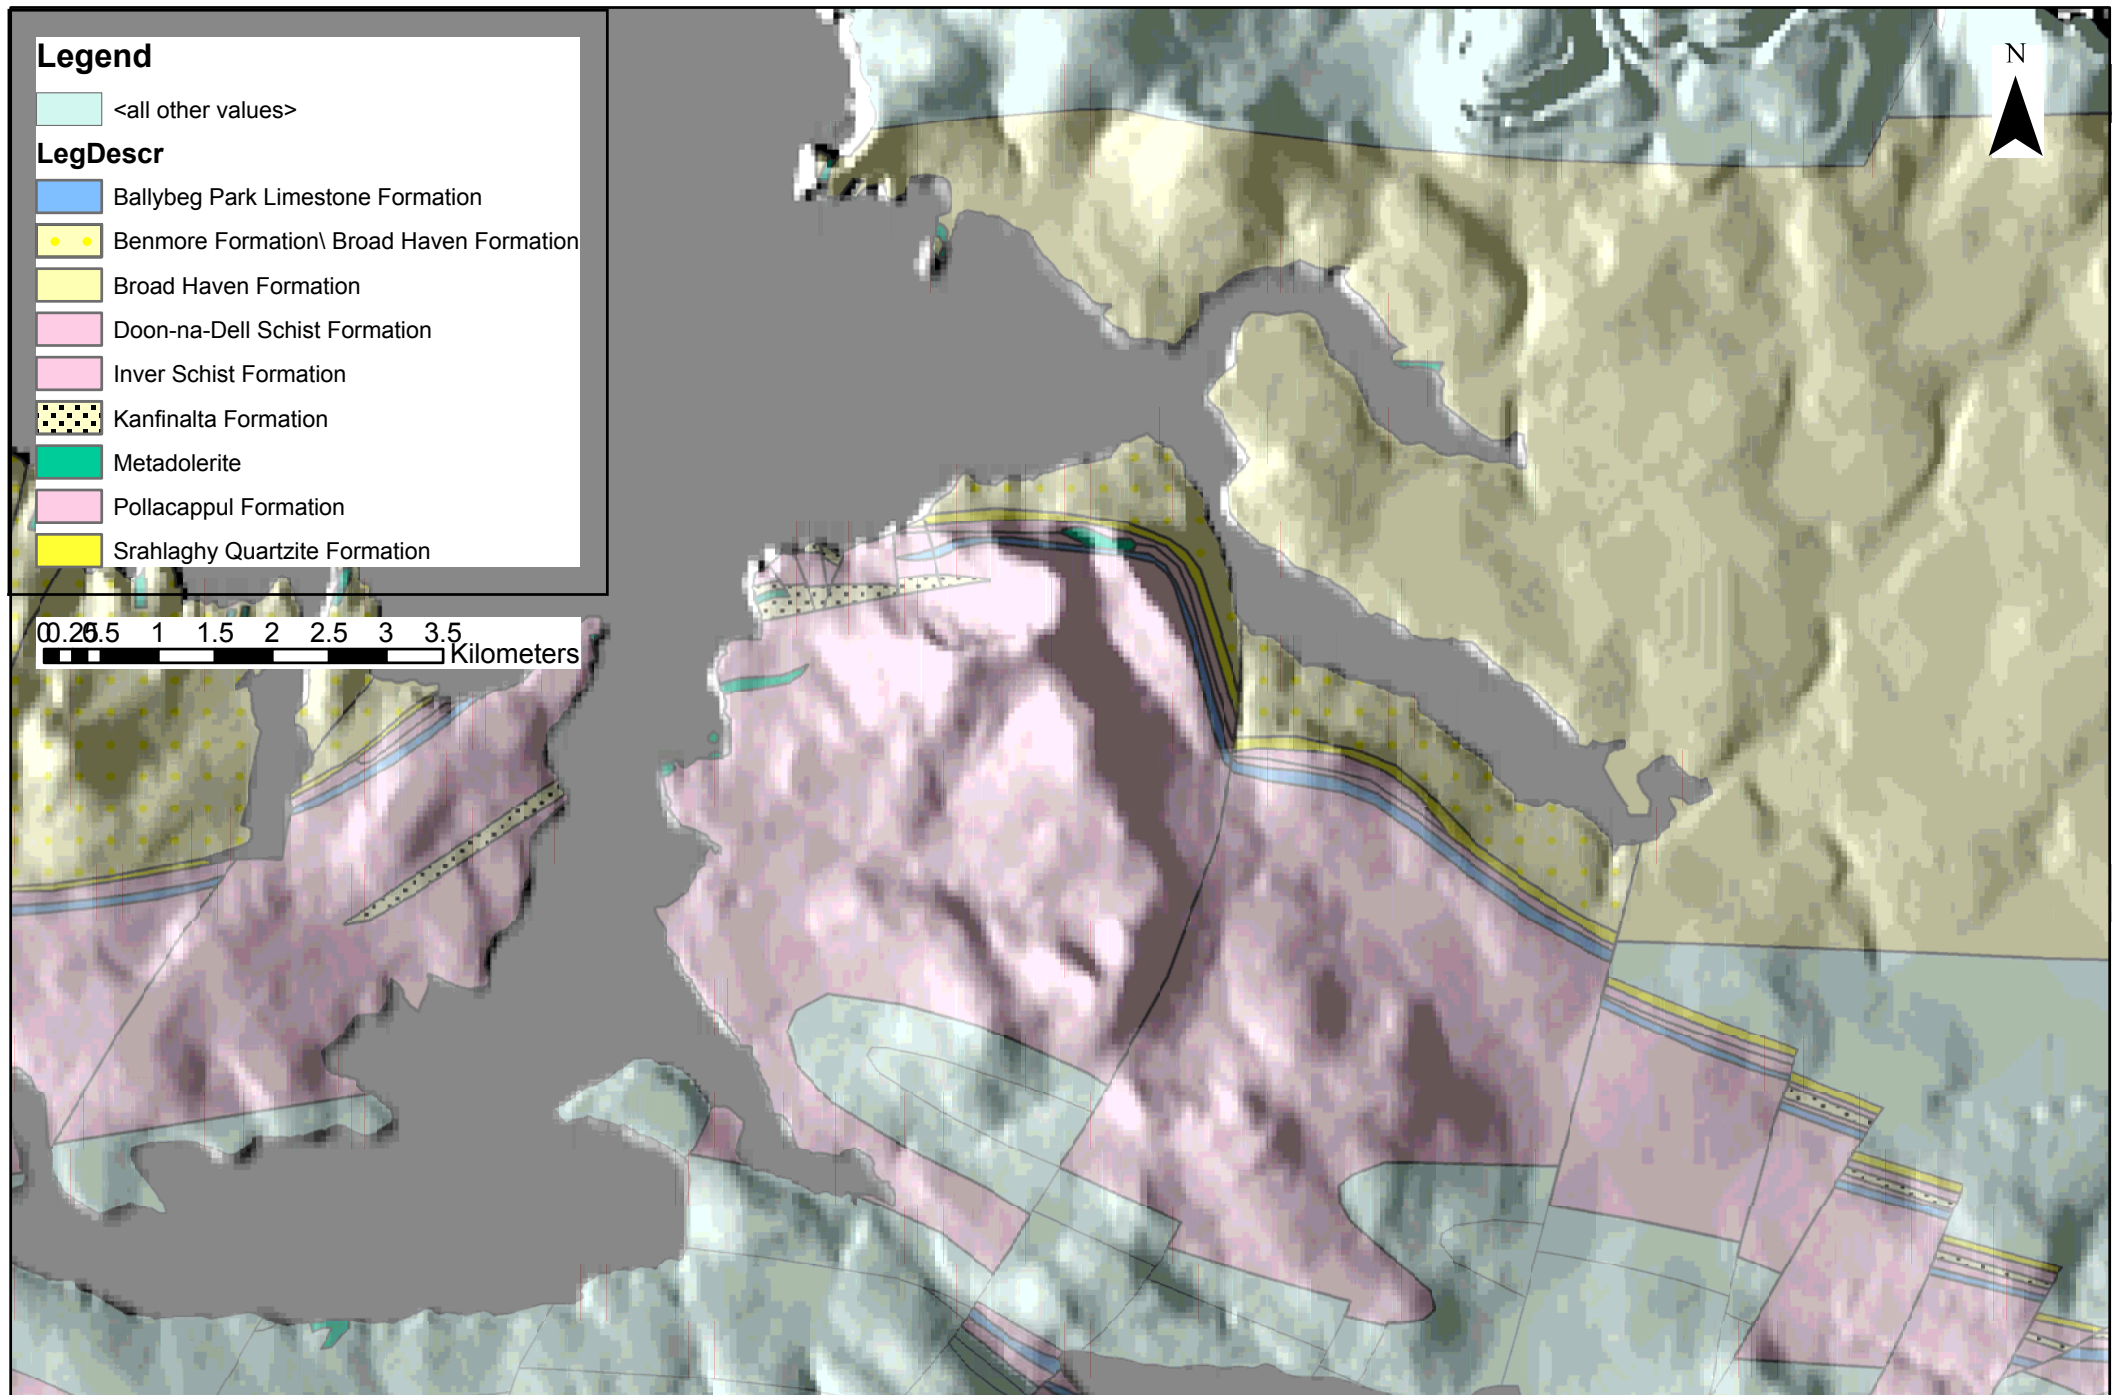
Fig 3. Geology and 270 deg. relief shaded DEM of the Pollatomish Area.

Figure 3. Geology and 270 deg. relief shaded DEM of the Pollatomish Area.

The role of the bedrock geology in the landslide event is critical but indirect. The presence of the high ground and slope profile is controlled by the underlying geology, the folding and faulting of which has resulted in the current relief. The different hardness of adjoining formations, such as hard metamorphosed sandstones and more easily weathered schists, has resulted in the stepped profile of the hillside. A north-south fault line, which may contain material which is easier to erode than the surrounding rocks, forms part of the course of the stream flowing into the bay at Pollatomish. Another important factor is that these rock types are all highly impermeable, being tightly cemented and compact, thus have a high run off rate during rainfall compared to more permeable rocks such as younger limestones or sandstones.
